KACHINA TEST SERIES: DYNAMIC ARCH TEST THREE (DAT-3) ANALYSIS REPORT

March 1986

Final Report

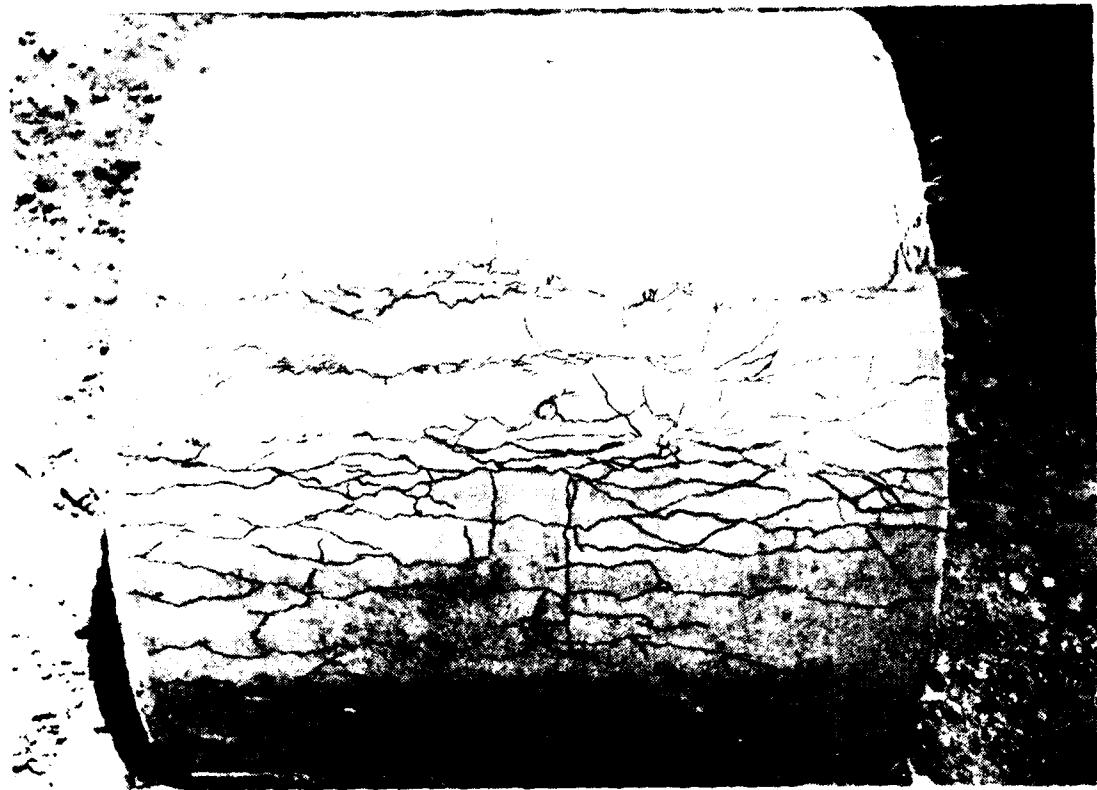
Figure 29. North side A6.

Arch segments A5-1, A5-4, A6 and A7 displayed similar types of damage. (See Figures 29 through 35 and the photographs and drawings in Appendix C.) The floors of the structures buckled inward because of the downward movement of the arch walls. Extensive cracking in the floor occurred in the central portion, starting at approximately 152 to 228 mm (6 to 9 in) from the interior corner or chamfer. After the arch walls had moved sufficiently to compact the underlying soil, a longitudinal crack developed on both sides of each arch. Each crack began at the end point of the circumferential splice hook cast in the corner of the wall and ran along the outside of the arch, approximately 530 mm (20.9 in) above the base of the structure.

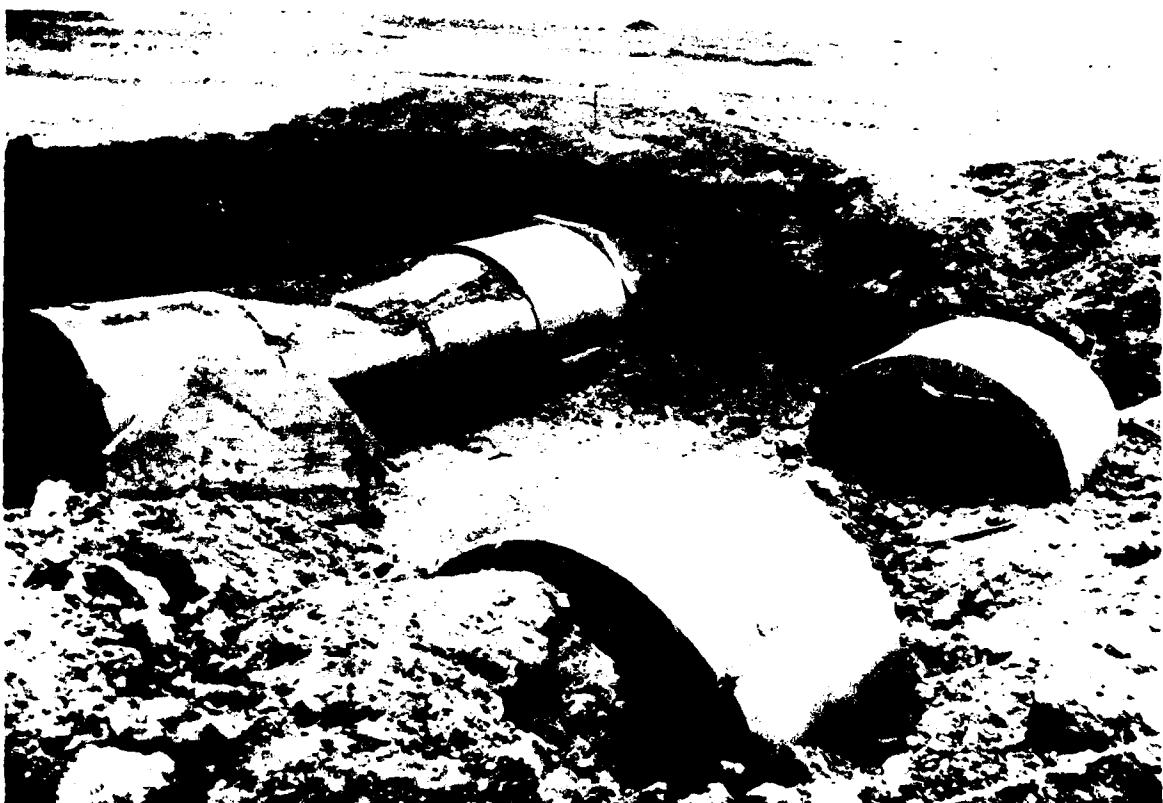
A general examination of the test-bed from the upstream and downstream sides can be found in Figures 62 and 63, respectively. The excavated test-bed surrounding the arches illustrates the shallow-buried fielding of the arches during testing. The large chunks of concrete visible inside each structure are pieces of spalled concrete which would have had adverse effects on any unprotected contents within the arches. The vertical pipes visible in each arch are the passive relative displacement gages. Referring to Figure 62, the 1.7-m arch in the foreground is A7. Arch A6, resting on a foundation, is visible as the 1.7-m arch at the far right. Arch A5 is the four-segment arch, with the butt joint at the farthest red line, and the keyed joint at the middle red line; the closest red line is the butt joint with the elastomeric pad. While the midsections of A5 show a total collapse of the arch, the two end segments resemble their counterparts A6 and A7 upstream. Near-field and free-field soil analysis presented in Section VI indicates that vertical soil motions in the center of the test-bed may have contributed to the collapse of the middle sections in A5, but the findings require further study. More information about this contribution will be made in later discussions.

Figure 62. View of test-bed from upstream north side.

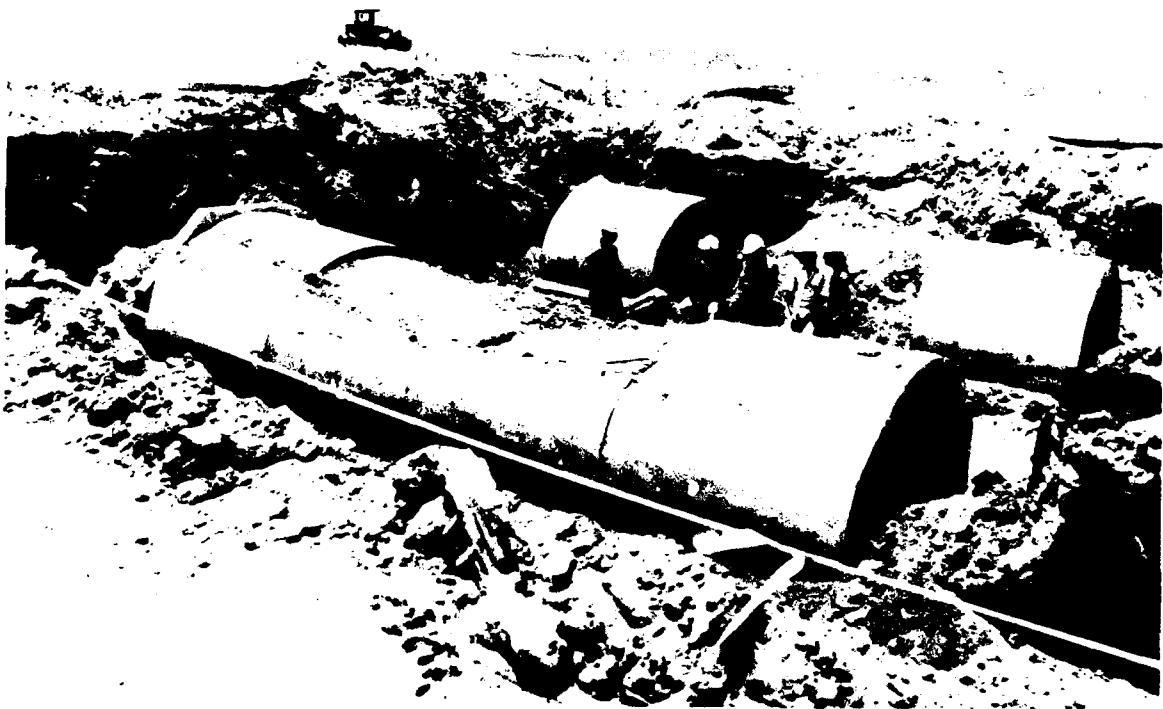
Figure 63. View of test-bed from downstream north side.

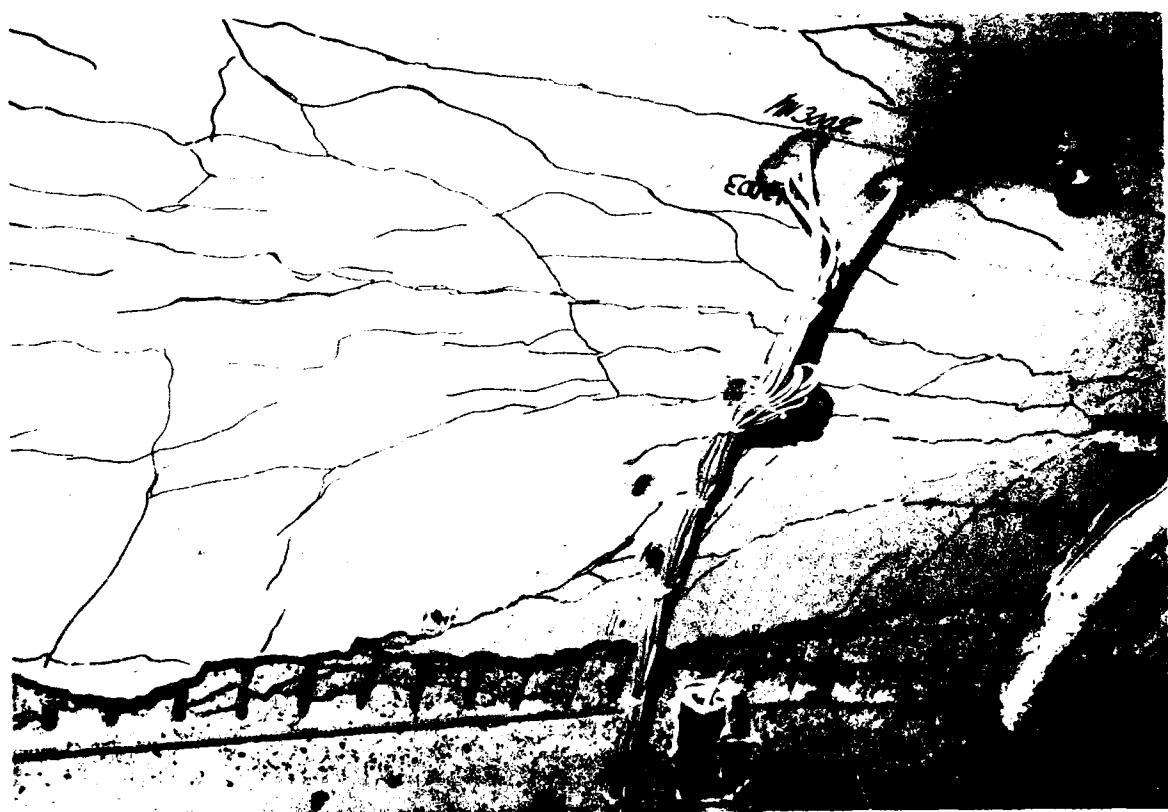
Figure 73. Interior upstream south end wall of Arch A5.

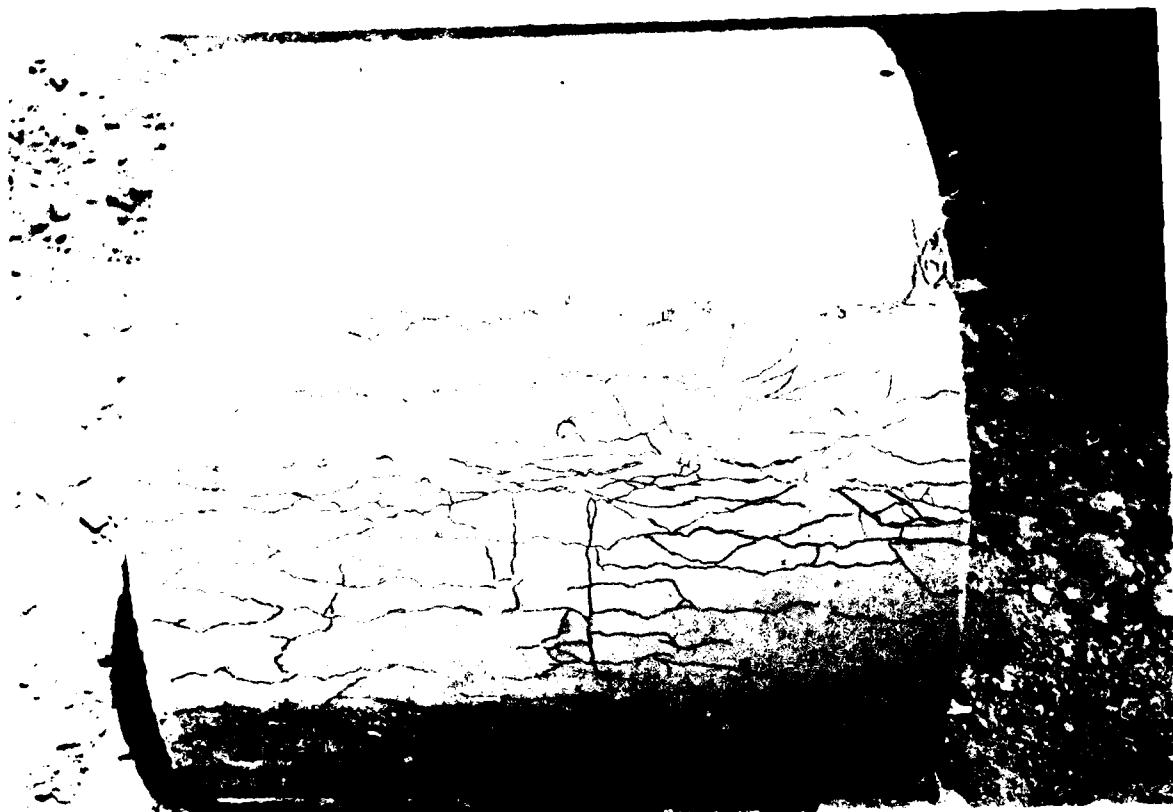
The exterior walls of A6 reflect less cracking at 60 deg from the crown than the other DAT-3 arches. As shown in Figures 78 and 79, the upstream side has major failure planes only at 30 and 50 deg from the crown (slightly higher than A5), while the downstream exterior shows the same major failure zone and an additional secondary crack zone at about 75 deg from the crown. This secondary crack zone has moved from the upstream side of A5 to the downstream side of A6. Photos of A7 will help to correlate this effect as a slight variation or a change in response caused by the footing.

Figure 78. Upstream exterior of Arch A6.

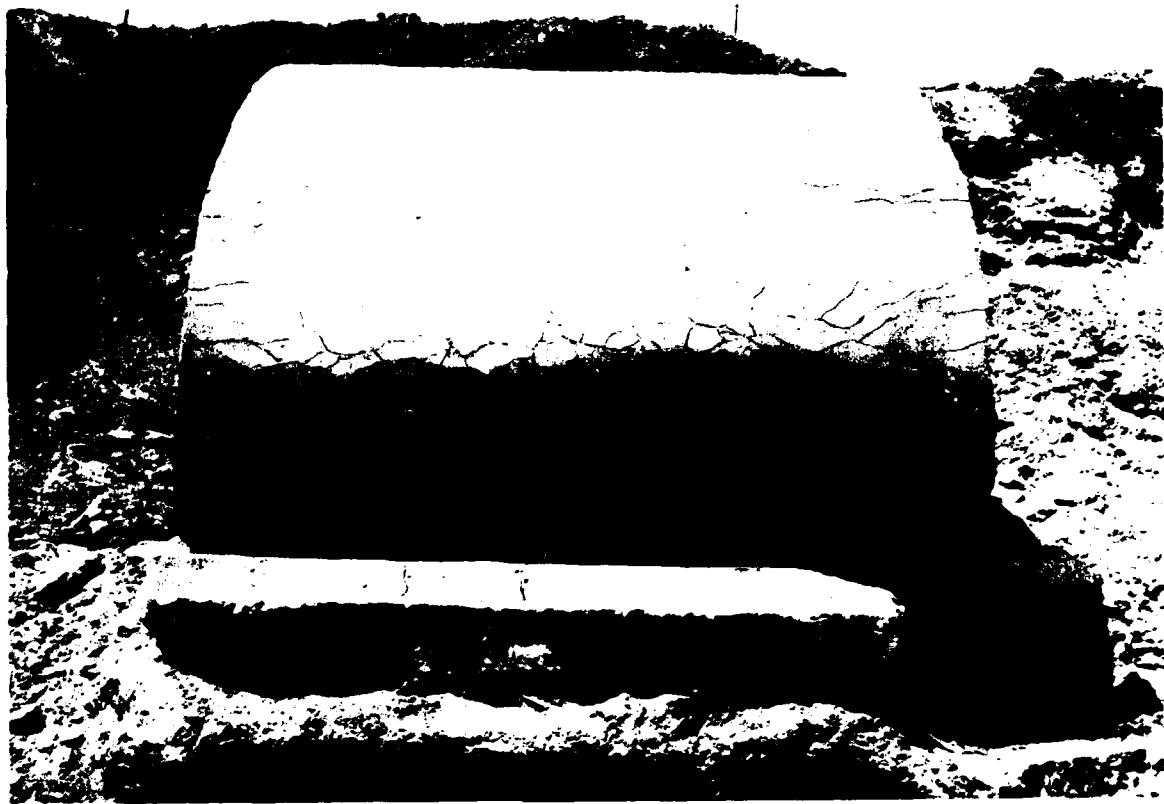
Figure 79. Downstream exterior of Arch A6.

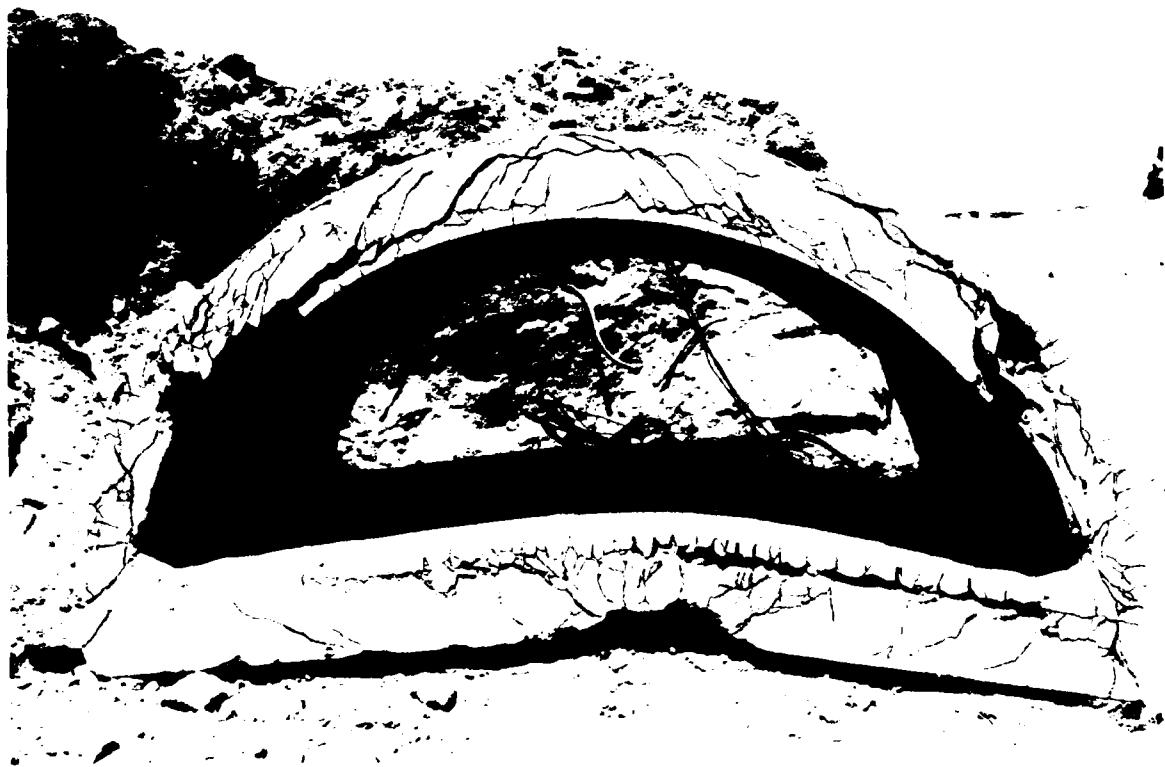
End views of A7 are presented in Figures 84 and 85. This arch is similar to the end sections in A5, whereas failure is concentrated at the 45- to 60-deg points in the walls and at the floor center. Very little cracking is evident at the edges of the floor relative to A6. Tensile cracking is evident in the interior crown and inner floor surface in the same pattern as that seen in A5. Both the upstream and downstream side chamfers, at the edge of the floor, are undisturbed.

Figure 85. South end of Arch A7 (upstream is left).
